Efflorescence Bulletin for Homeowners

PRODUCTS INTERNATIONAL

TECHNICAL BULLETIN

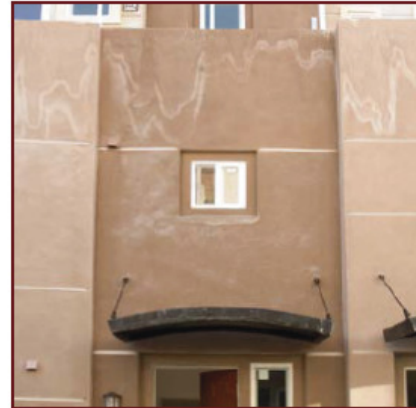
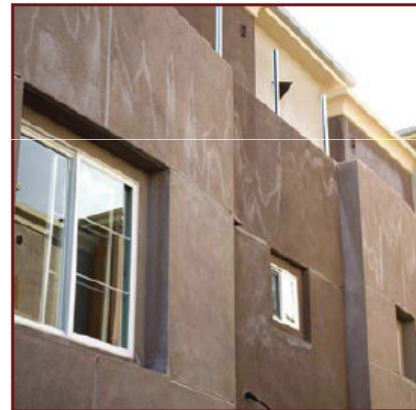
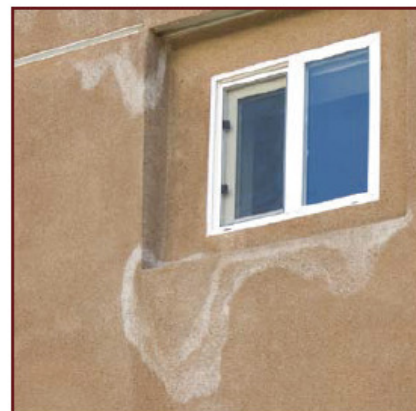
Efflorescence is a natural phenomenon that causes white stains to occur on the surface of cement-based products, such as stucco plaster systems, concrete driveways, brick, or masonry. Cement-based products contain salts that are an inherent part of the raw materials. During periods of wet weather, moisture can cause these salts to travel through the cement matrix to the surface causing the walls to turn white. Fresh cement-based products are particularly susceptible to efflorescence.

Although this white residue is aesthetically unpleasing, it does no harm to the wall assembly. In fact, efflorescence is a common, natural occurrence and should not be considered a product or application defect.

Fortunately, there is a relatively simple, effective method to deal with efflorescence problems. The repair process itself is called fogging, and the material used during the repair is called fog coat.

Fogging is a common process used to even out the color on most new stucco applications today. In fact, there is a good chance your home has already been fogged. Omega Products International's fog coat product is called Omega Coat, which is a blend of cement, water, and dry pigment. Omega Coat is manufactured using the same pigments and cement as the stucco finish originally applied to your home. Omega Coat is sprayed onto the wall, but, unlike paint, it will not chip, peel, or fade. The fog coat becomes an integral and permanent part of the original stucco finish, restoring your home to its original color.
